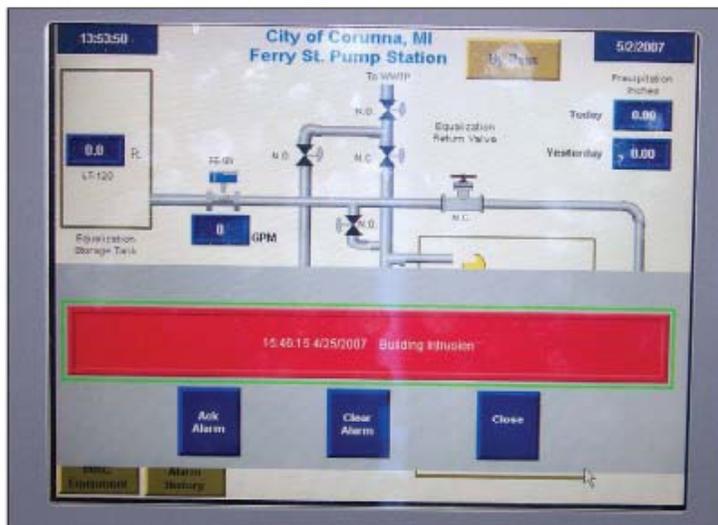
The computerized Ferry Street Pump Station uses the RSView 32 monitoring package from Rockwell Automation. A laptop computer equipped with PC Anywhere software from Symantec turns pumps on and off remotely.
